Pest & Building Report

6 Sample Street Suburbia

Sample Inner City Cottage

BUILDING INSPECTION REPORT Summary

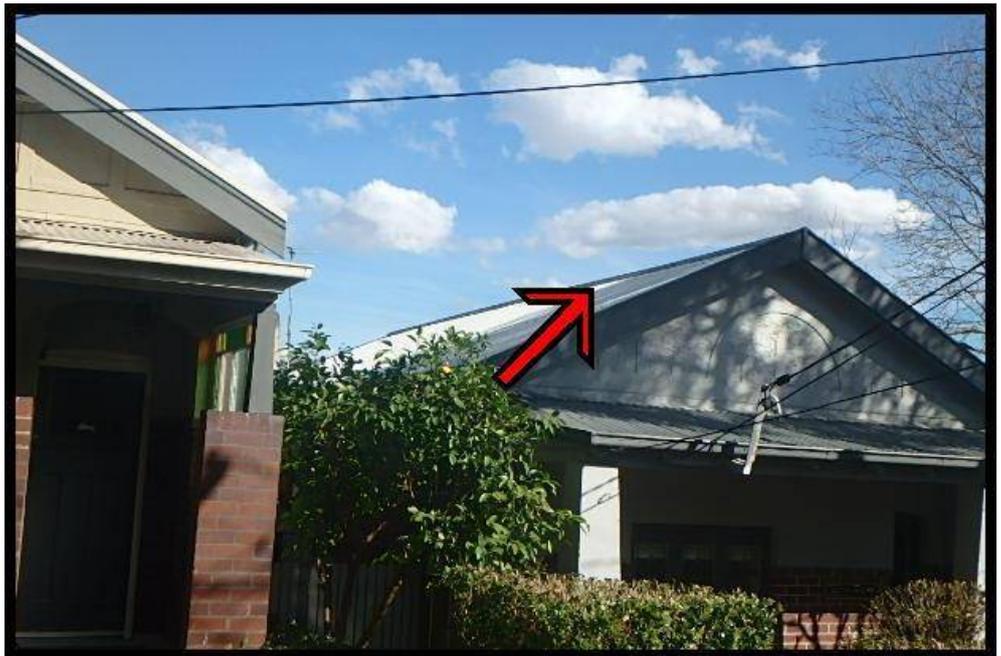
Roof Covering Condition in Detail:

The overall condition of the roof coverings is good.

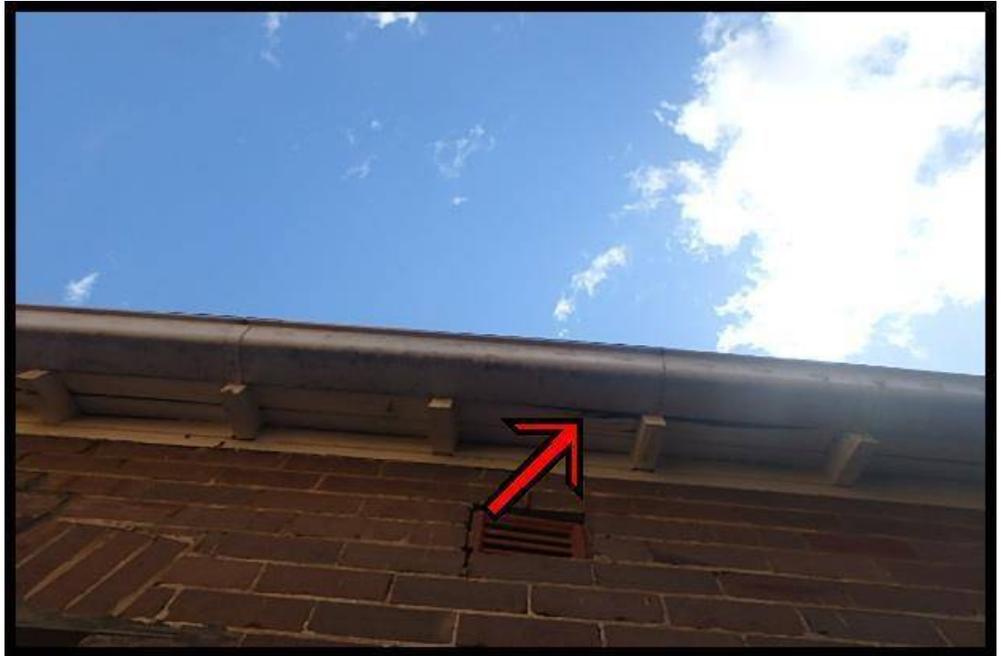
Eaves Type & Condition:

The eaves are lined with timber lining boards. The overall condition of the eaves lining is fair. Minor wet rot decay is present to timber eaves lining boards.

The overall condition of the fascias/bargeboards is fair. The paint work is deteriorating and maintenance is required.

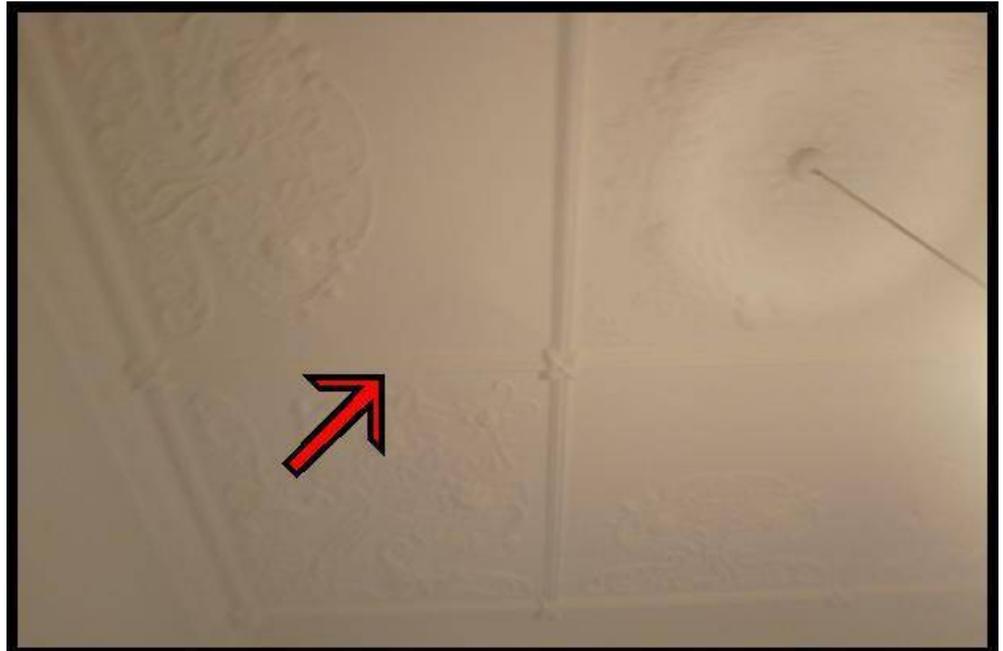
Ceiling Condition:

The condition of the ceilings is generally good. Some minor blemishes were present on the ceiling linings.

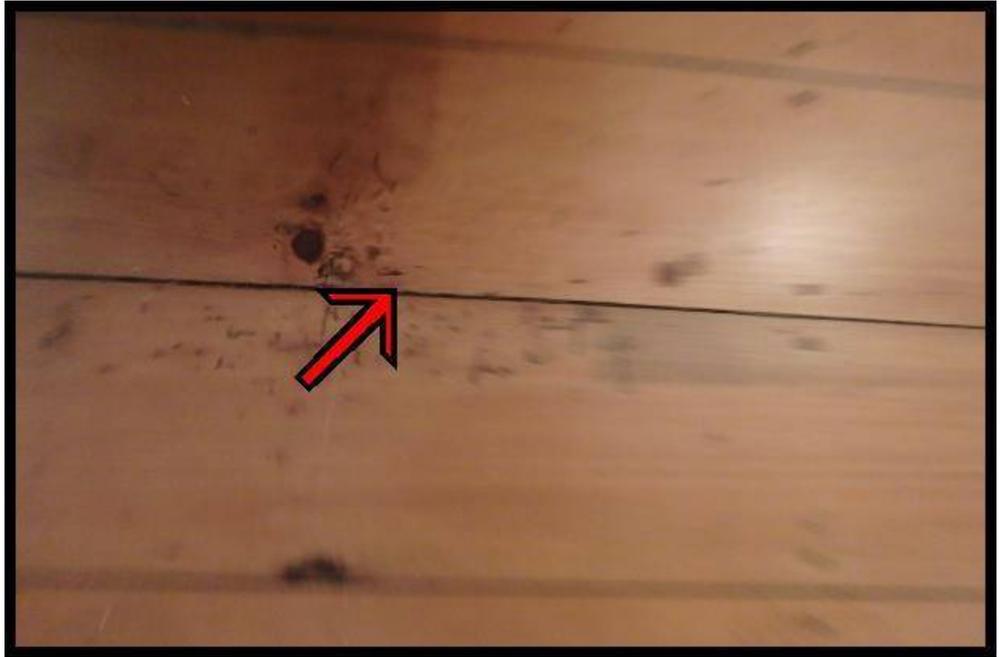
Floors General Condition:

The condition of the floors is generally good. Evidence of what appears to be timber pest attack was noted to flooring. Please refer to pest inspection report for details. Various internal areas.

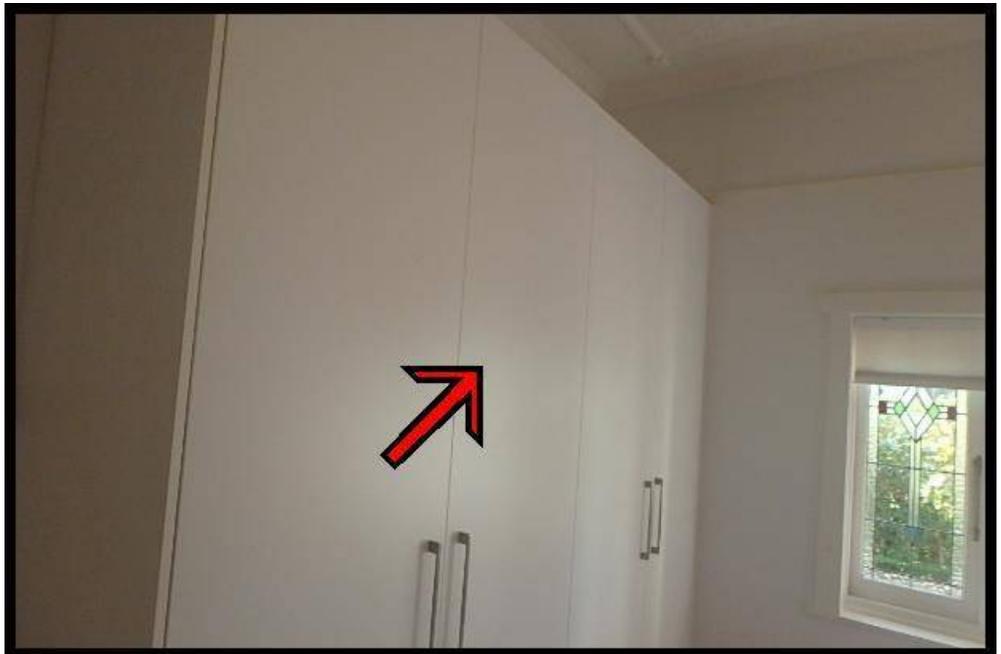
The condition of the built-in wardrobes is generally good.

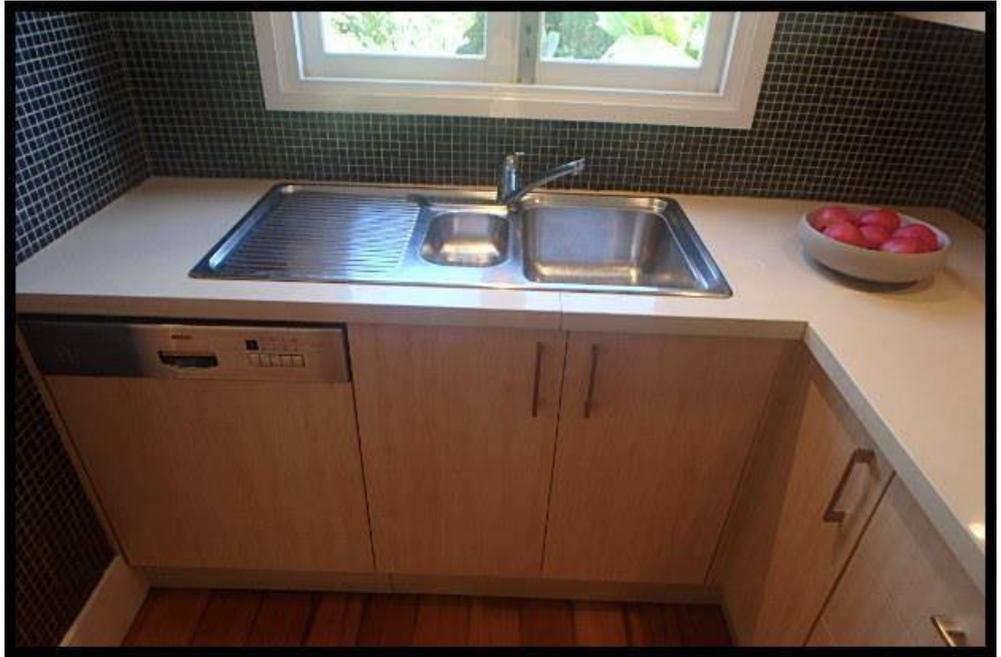
Kitchen Fixtures:

The condition of the fixtures is generally good. Wear and tear is noted to cabinets and/or doors and some maintenance or repairs will be required.

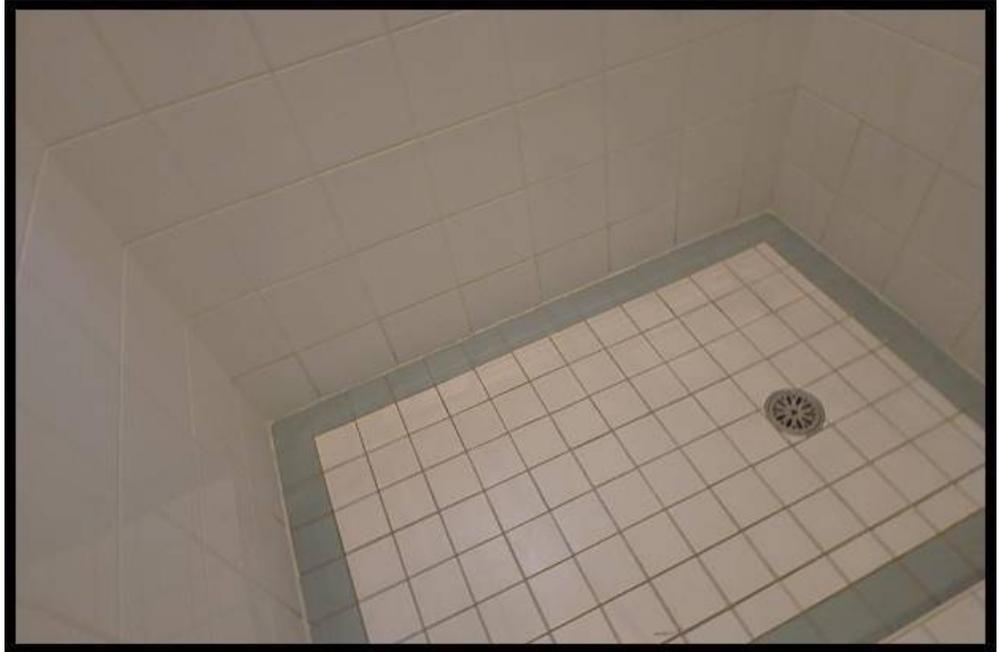
Shower/Bath Condition:

The shower recess was tested and there was no visible water penetration to surrounding areas. **IMPORTANT NOTE:** This test may not reveal water leaks until the shower is put into constant use and surrounding areas monitored over a period of time.

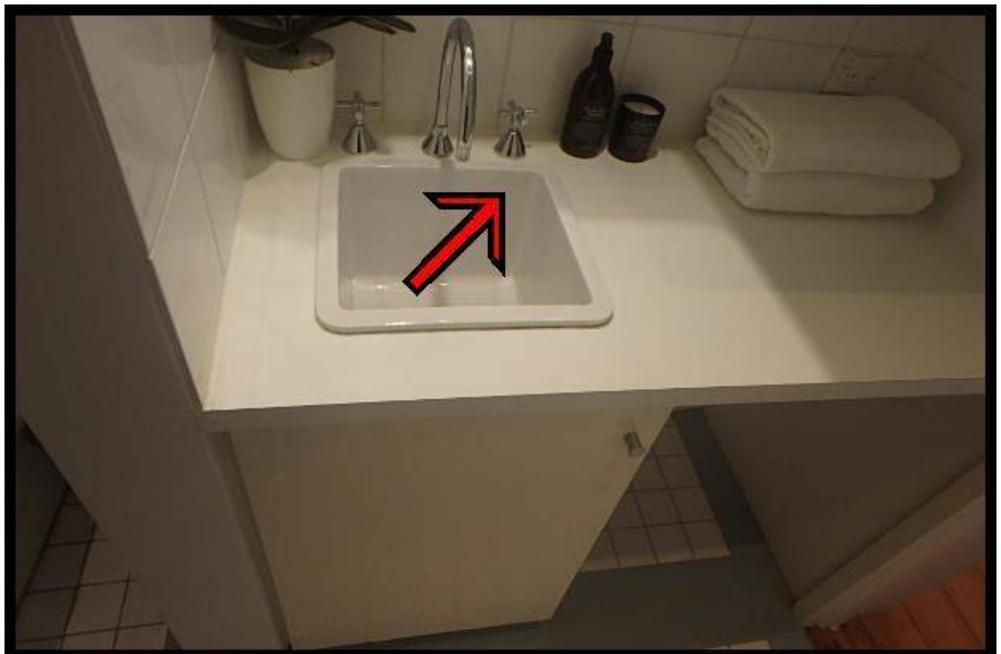
Tub & Taps:

The tub and taps appear serviceable.

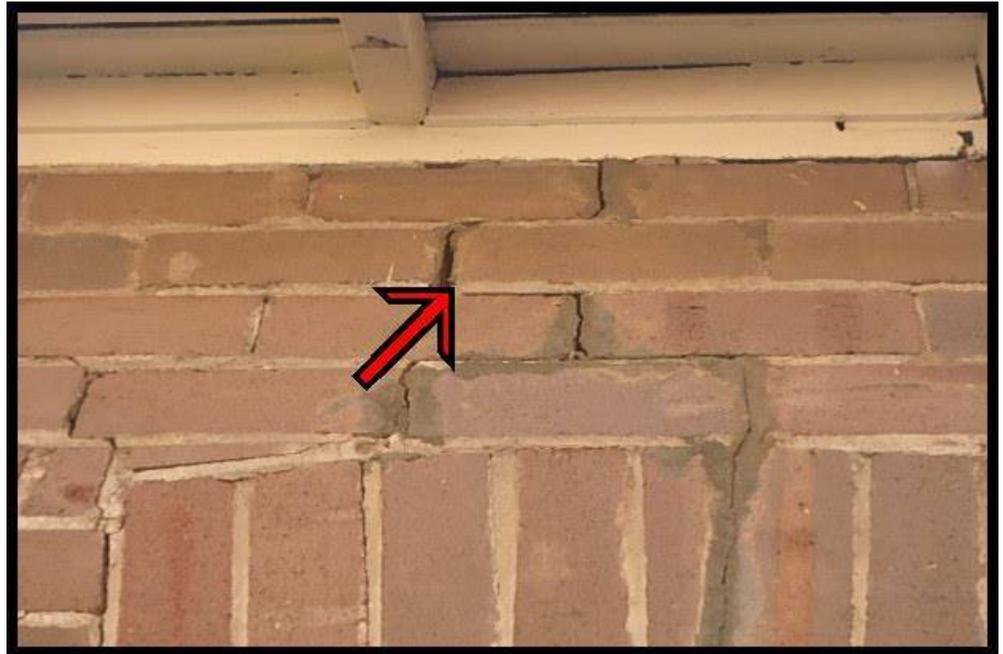
Cracking to Masonry or Concrete Elements:

Cracks are evident. Visible cracking has been categorized as a serviceability defect. Cracking of a building element is a serviceability defect where in the opinion of the inspector the function of the building element is impaired however, the expected consequence of this cracking is unknown until further information is obtained.

Cracking can be expected in a building of this age and construction.

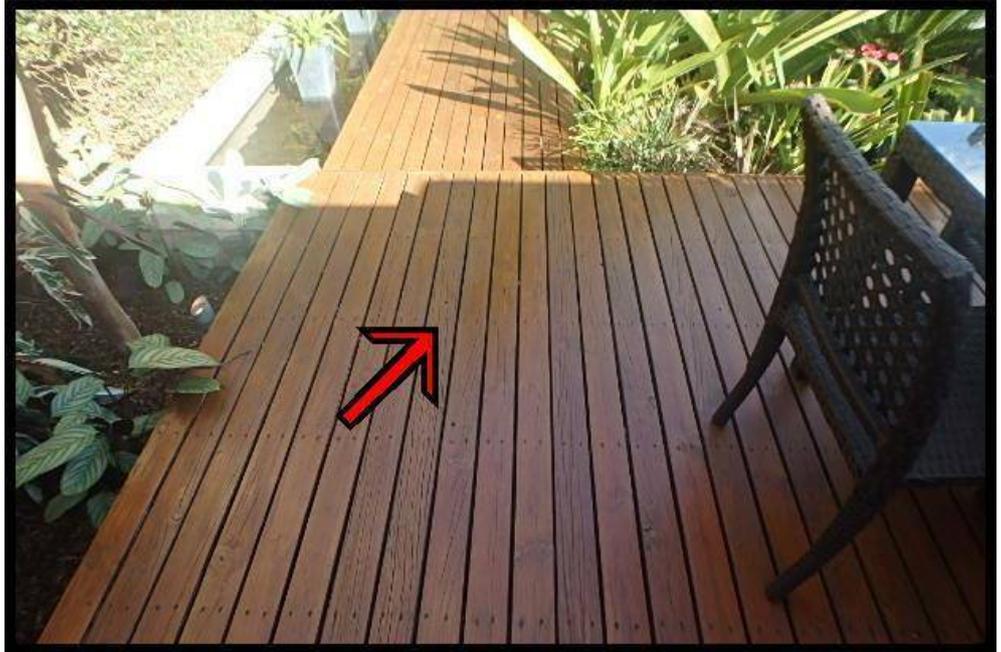
Rear elevation.

Constructed from timber. The general condition of this structure is good.

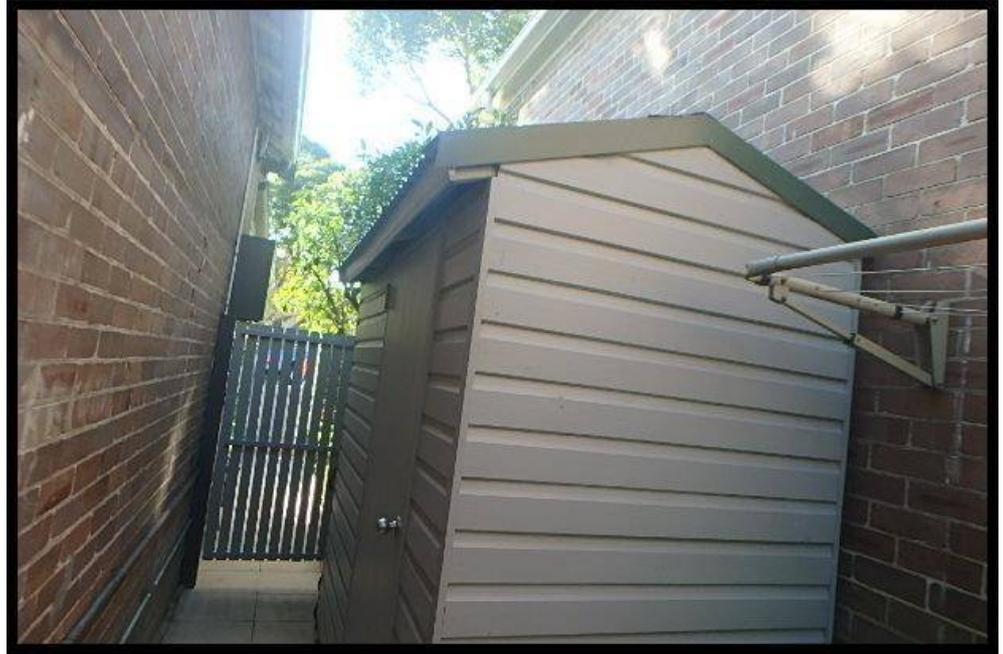
Shed:

General Condition: The structure is generally in good condition.

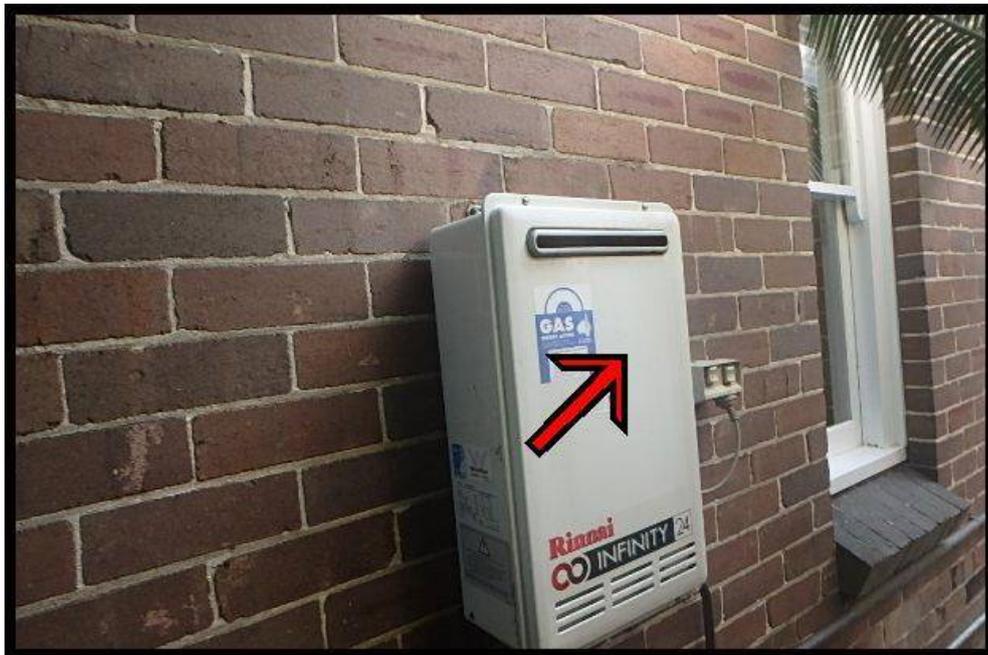
Gas hot water system: Instantaneous: Located externally: The hot water system appears to be in working condition. No specific tests other than running the hot water from a tap was carried out. No determination has been made as to the suitability or adequacy of the hot water system in relation to capacity or otherwise.
