# Pest & Building Report

**Sue Jones**

**435 Scenic Highway Anzactown**

Sample Lage Home on acerage

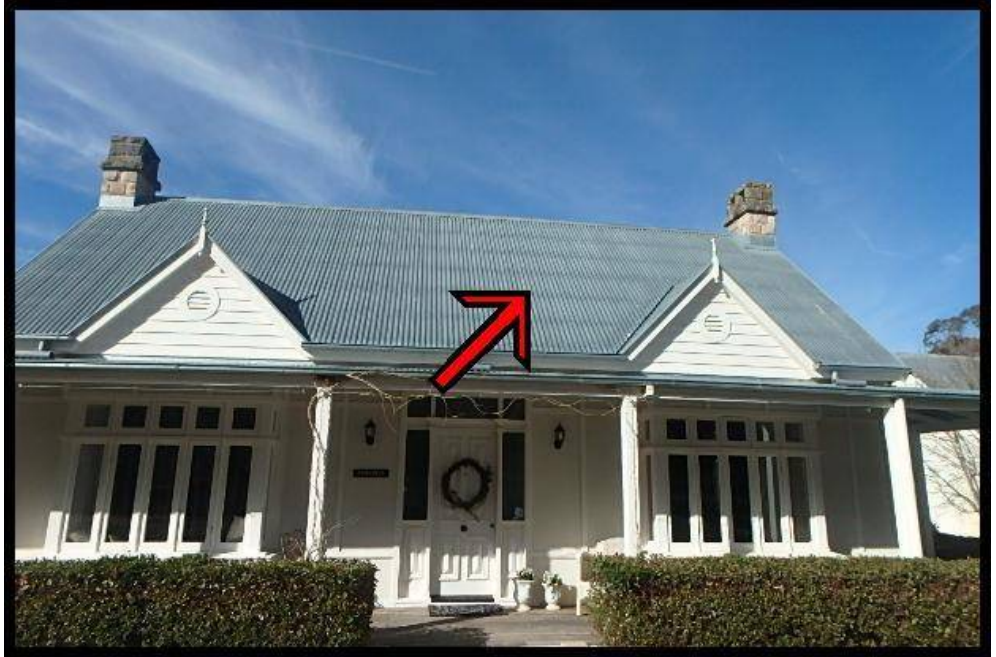
The overall condition of the roof coverings is good.

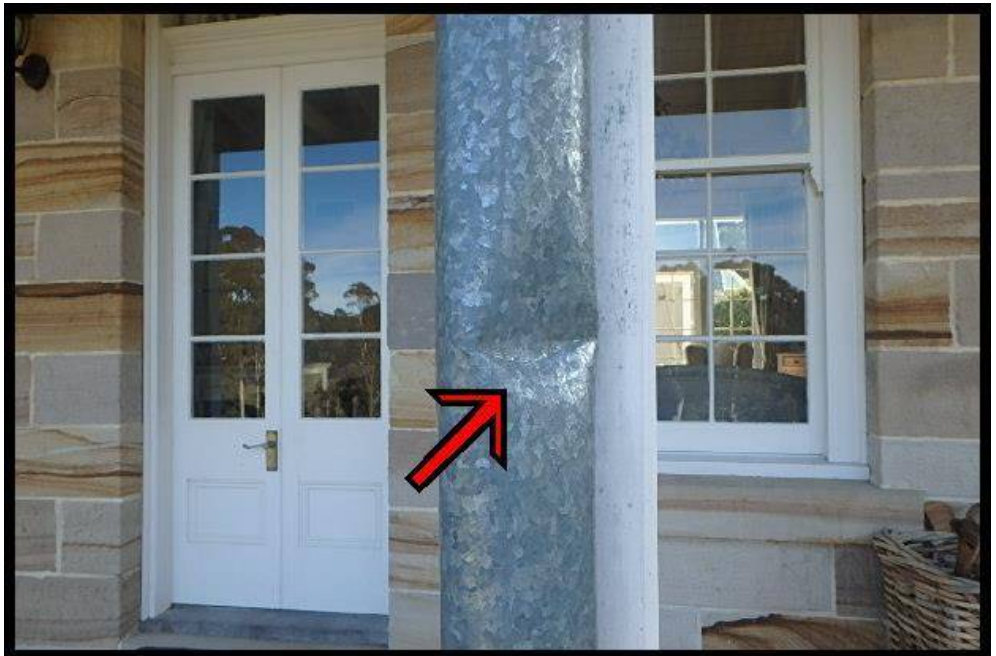
Appear to be in serviceable condition. Downpipes are damaged and should be repaired or replaced as necessary.

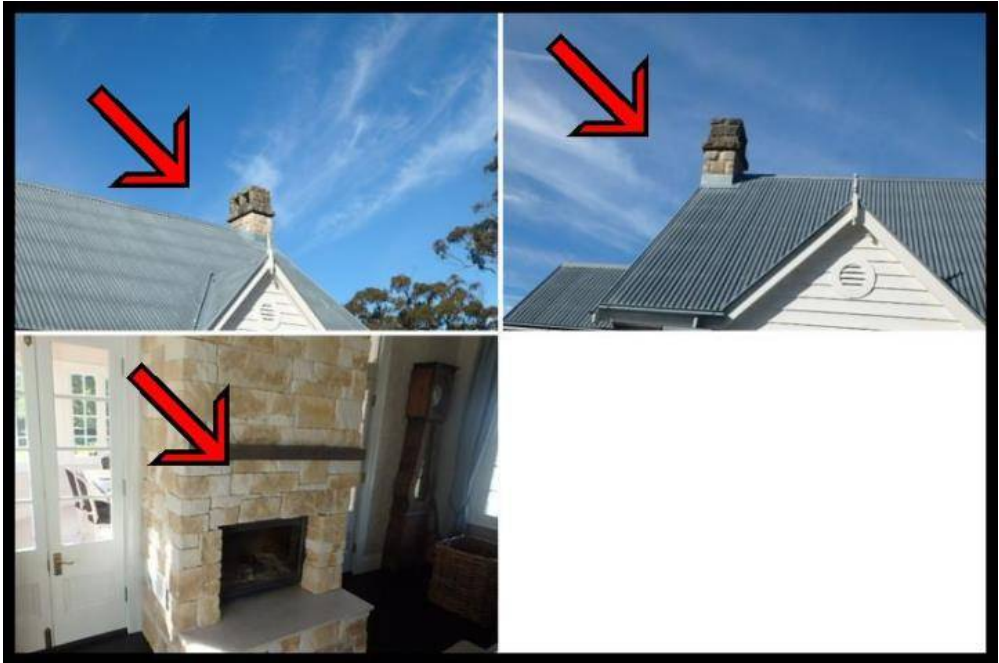
The flashing around the chimney is in good condition. The chimney should be tested and cleaned prior to being put into use.

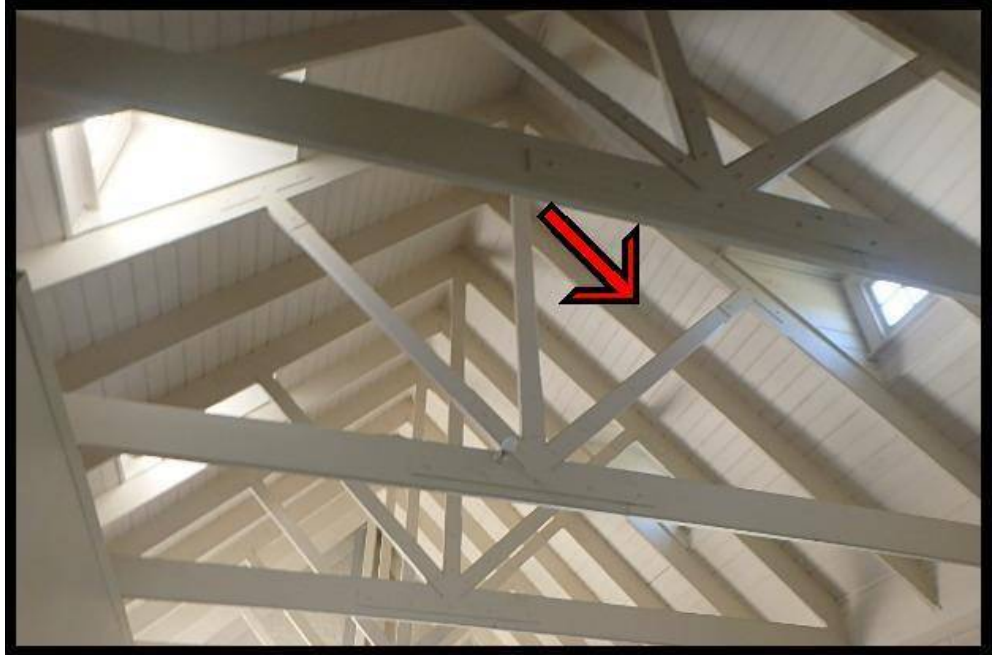
A section of the roof is of cathedral style construction. Ceilings follow the roof contour and in this section there is no accessible cavity present for inspection.

A section of the roof is of skillion style construction and in this section there is no accessible cavity present for inspection.

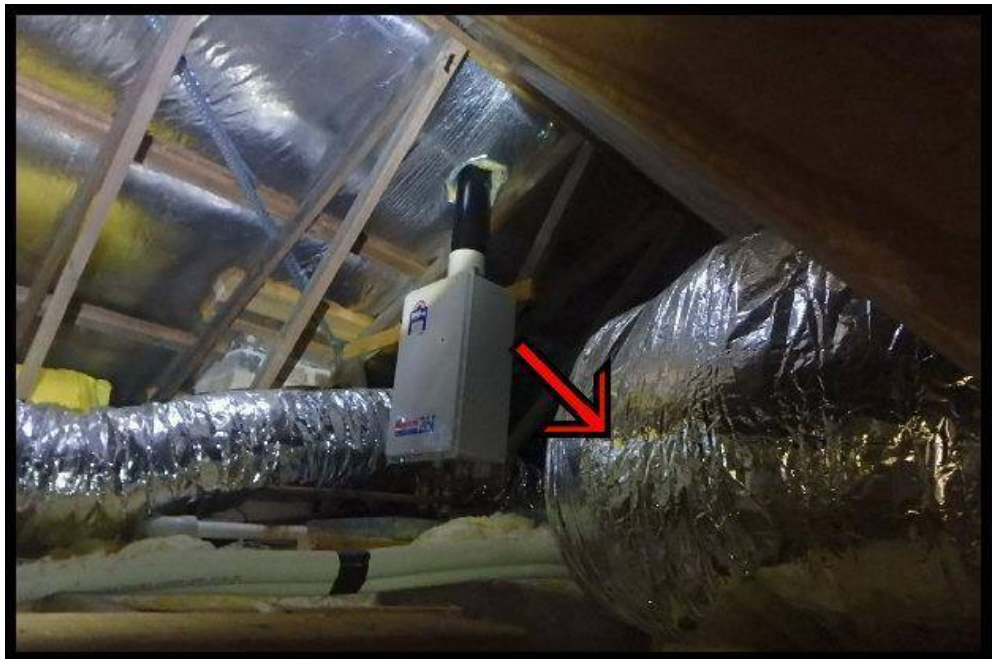
Inspection over the eaves was restricted due to the low pitch and construction allowing only a limited visual inspection from a distance to be carried out.

Insulation is present in the roof cavity. This restricted inspection to some roofing timbers. Removal of insulation is not within the scope of a standard visual timber pest inspection report however, this would be necessary for a more complete report to be submitted.

Ducting associated with air-conditioning or heating restricted inspection.

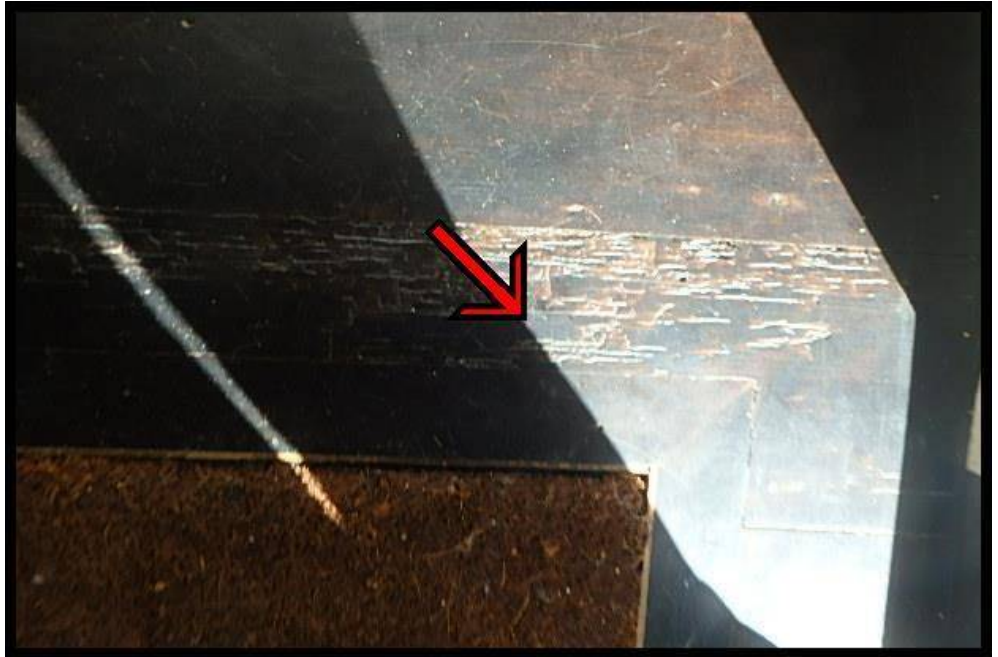
The condition of the floors is generally good. Evidence of what appears to be timber pest attack was noted to flooring. Please refer to pest inspection report for details. Cracks are evident. Visible cracking has been categorized as a serviceability defect. Cracking of a building element is a serviceability defect where in the opinion of the inspector the function of the building element is impaired however, the expected consequence of this cracking is unknown until further information is obtained.

Cracking can be expected in a building of this age and construction.

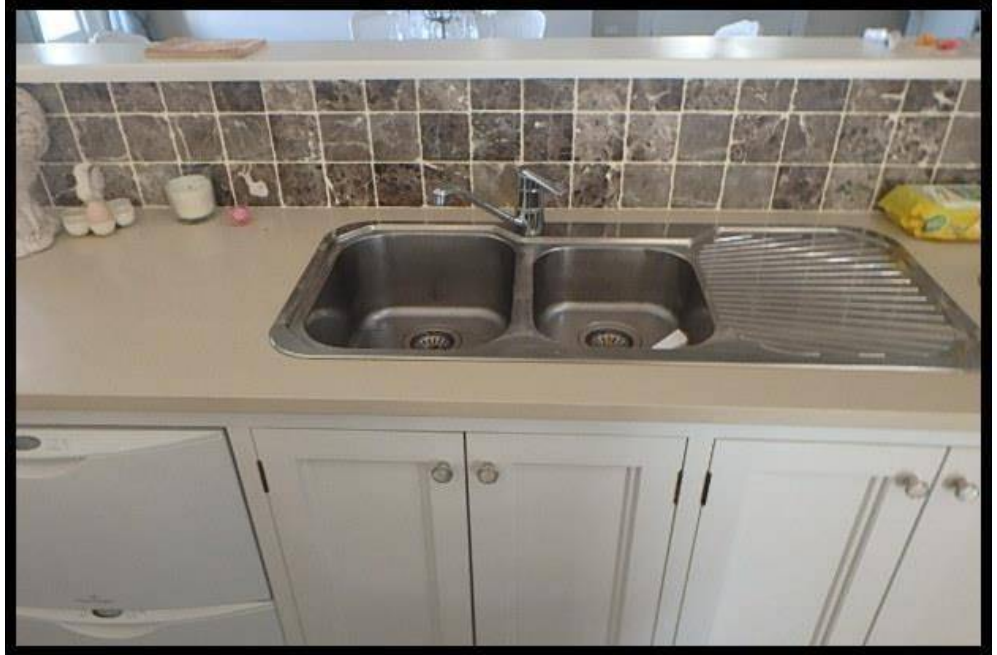
The condition of the fixtures is generally good. Wear and tear is noted to cabinets and/or doors and some maintenance or repairs will be required.

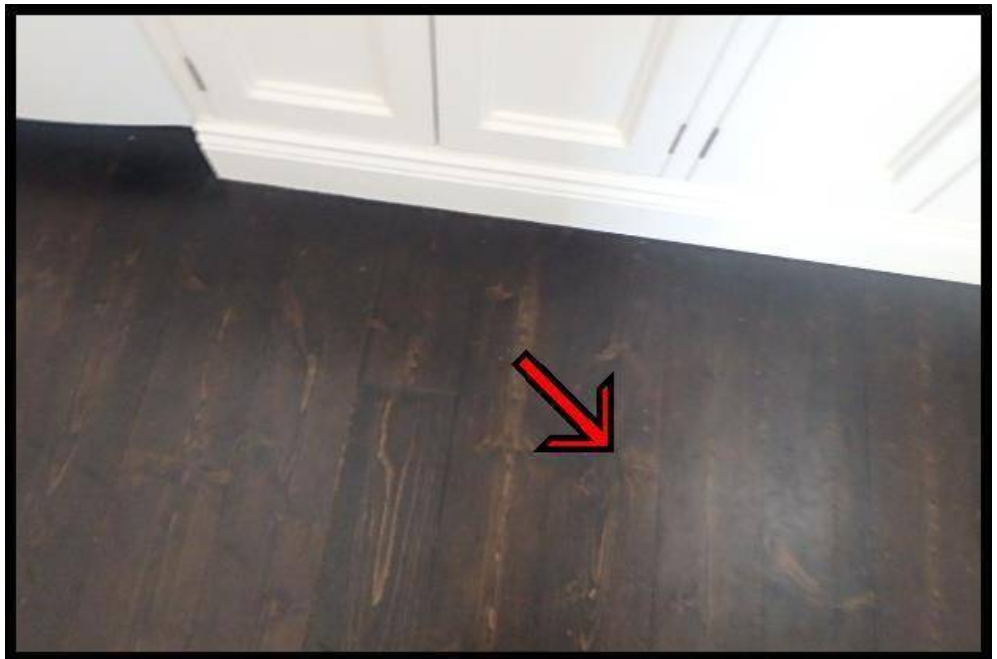
Tiles are not present to wet areas. Recommend tiles be installed to prevent water penetration.

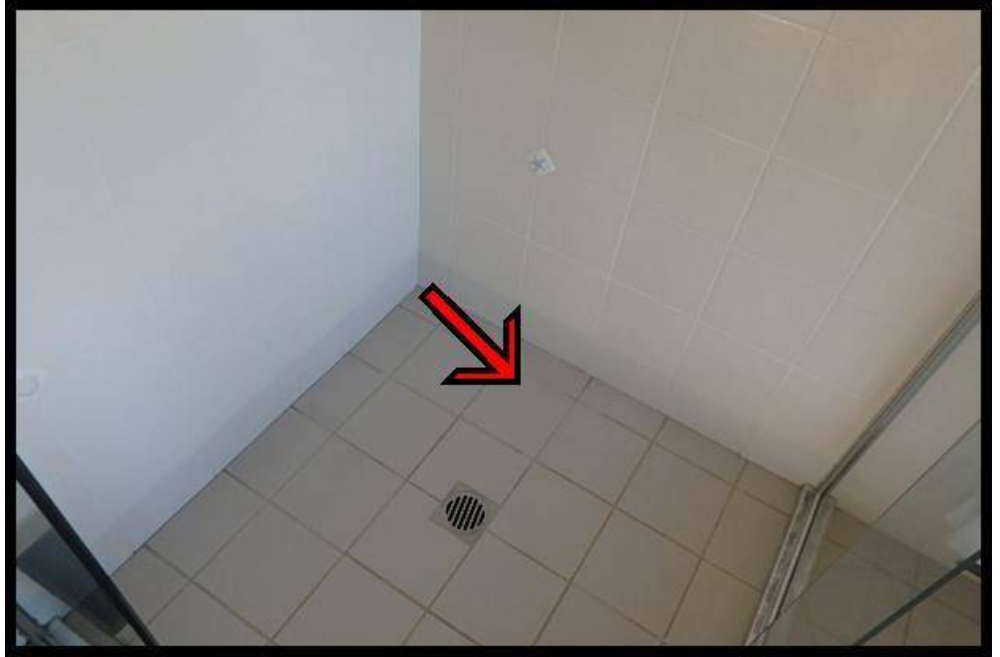
The shower recess was tested and there was no visible water penetration to surrounding areas. The waterproofing on the shower is out of warranty and we recommend the purchaser contact a shower waterproofing company to advise on further waterproofing & extended warranty options. IMPORTANT NOTE: This test may not reveal water leaks until the shower is put into constant use and surrounding areas monitored over a period of time.

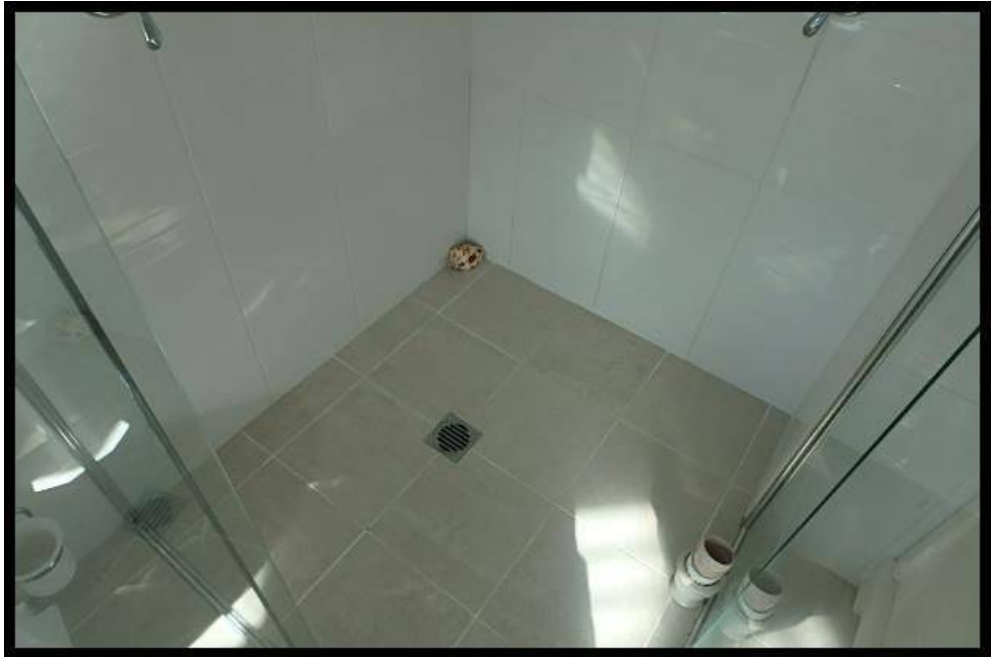
The shower recess was tested and there was no visible water penetration to surrounding areas. The purchaser should check with the vender that the shower recess is covered by the waterproofing company warranty. **IMPORTANT NOTE:** This test may not reveal water leaks until the shower is put into constant use and surrounding areas monitored over a period of time.

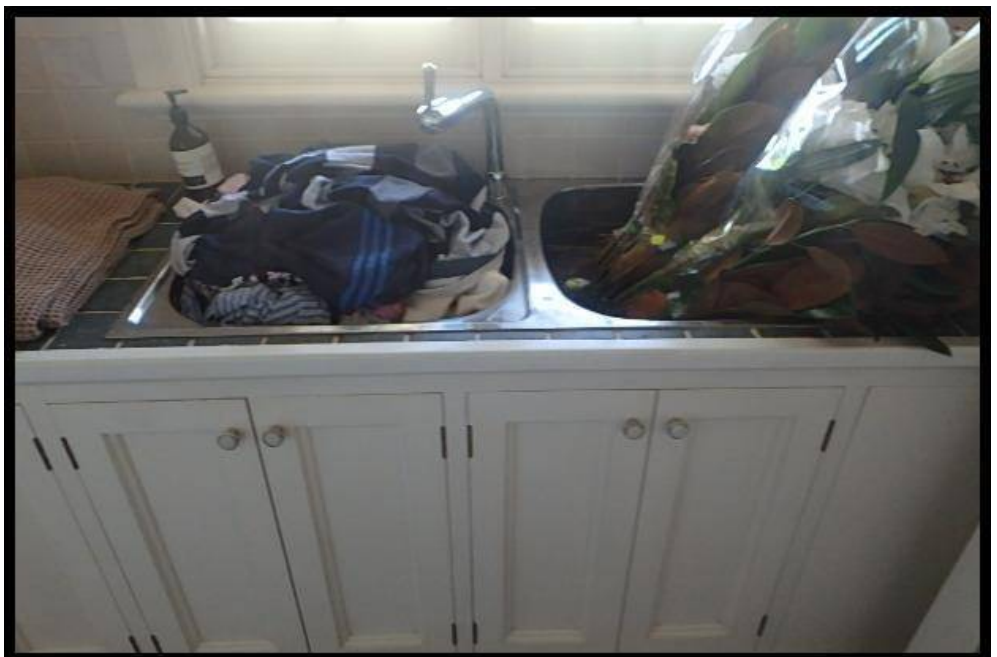
The tub and taps appear serviceable.

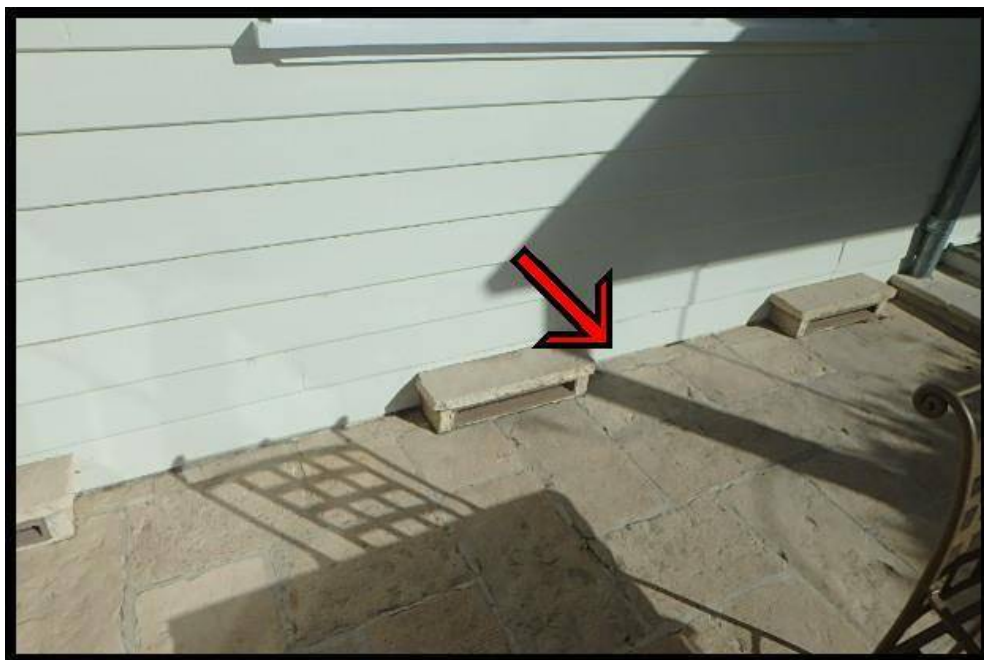
The condition of the walls is generally good. External timbers are in contact with or very close to soil areas. This is conducive to timber pest attack or timber deterioration and we recommend modifications be made so that timber to soil contact does not occur.

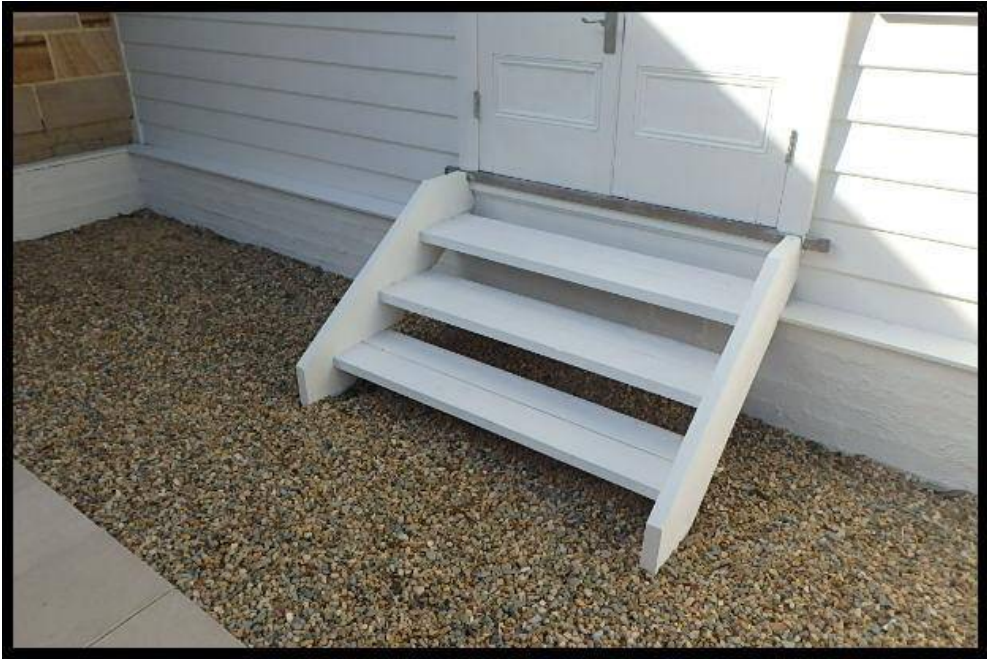
The stairs are constructed primarily from timber. The overall condition of the stairs is good.

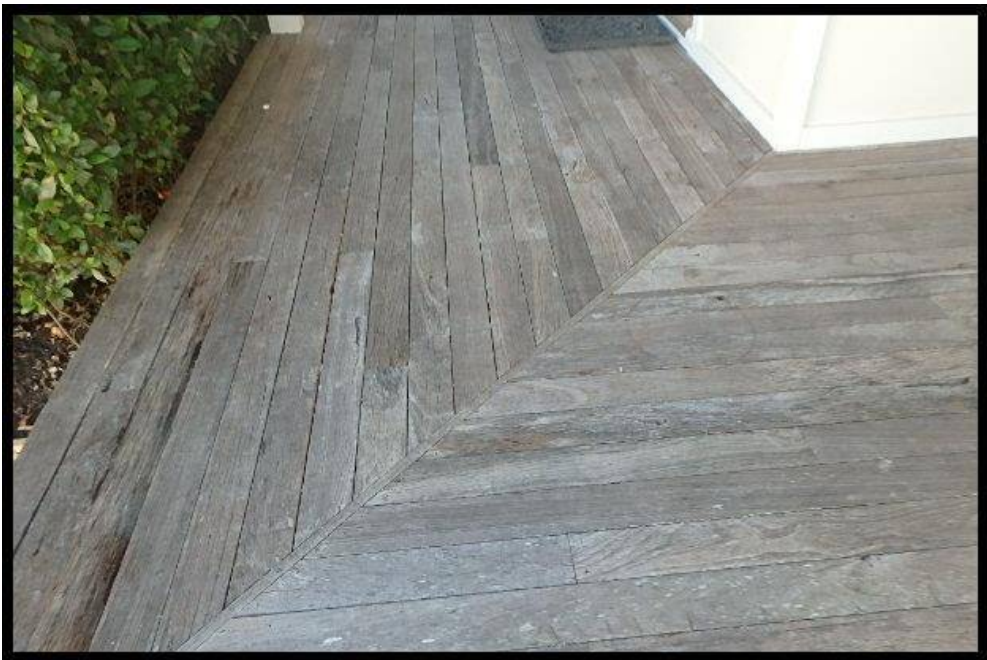
Constructed from timber. The general condition of this structure is good. The roof is of skillion construction.

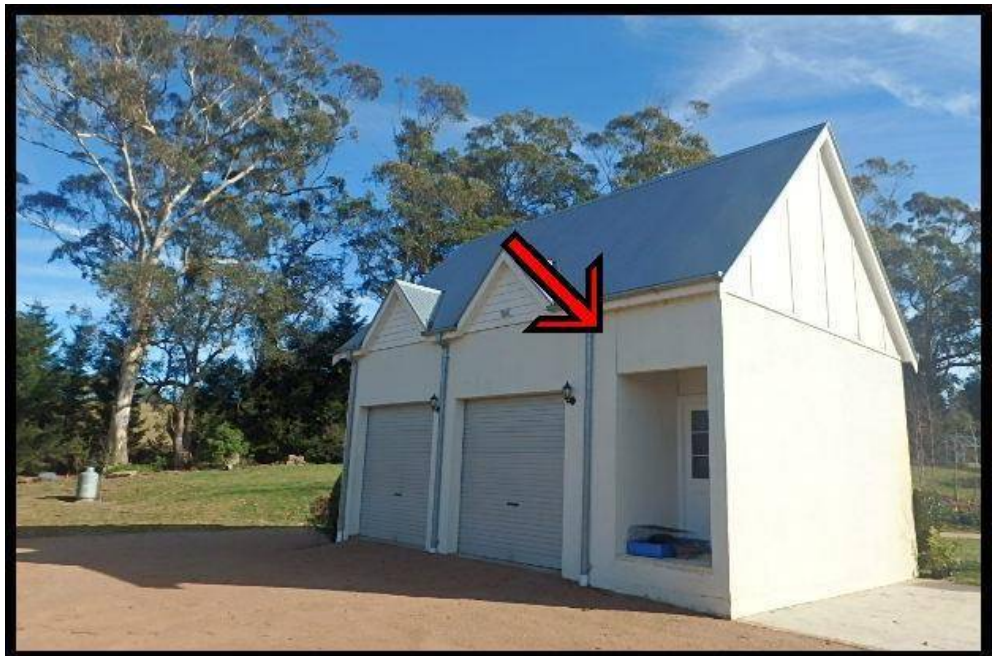
Under the main building.

**General Overall Condition:** The overall condition of the garage is good.

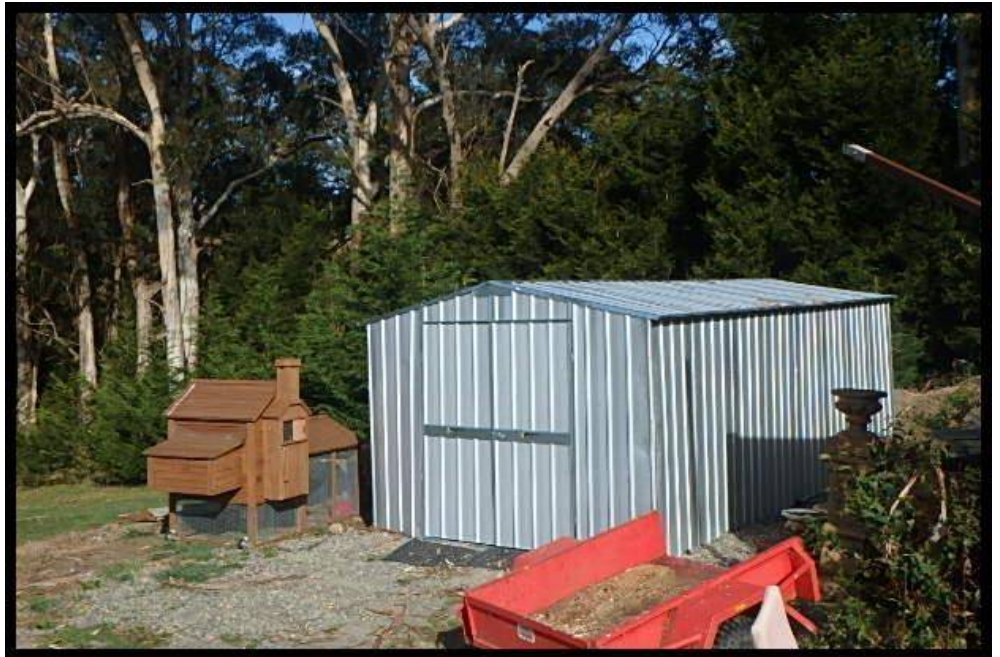
Metal garden shed:

The structure is generally in fair condition.

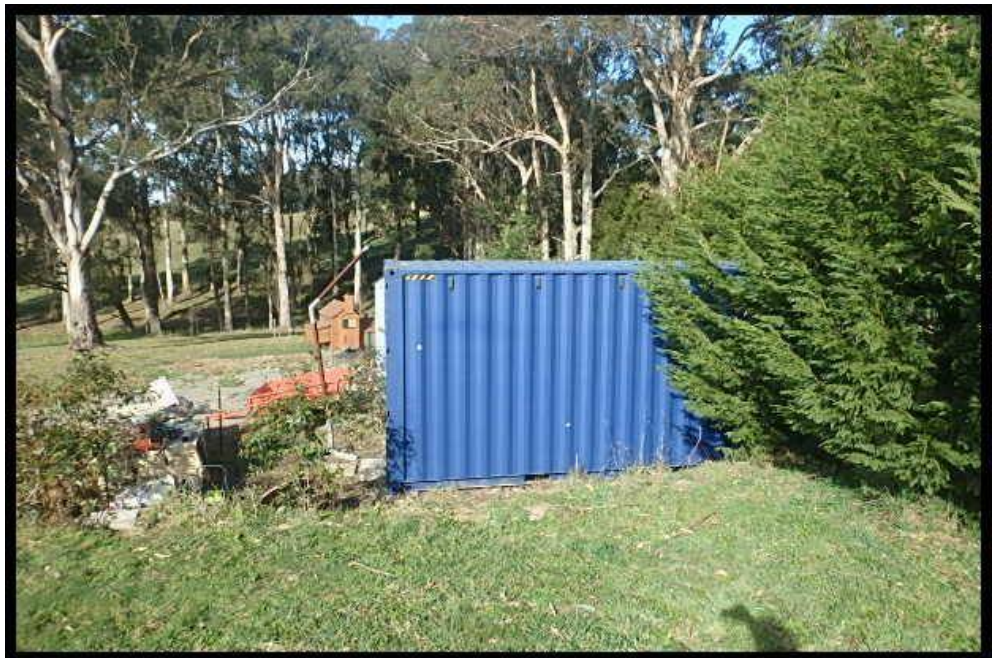
Steel Container.

The structure is generally in good condition.

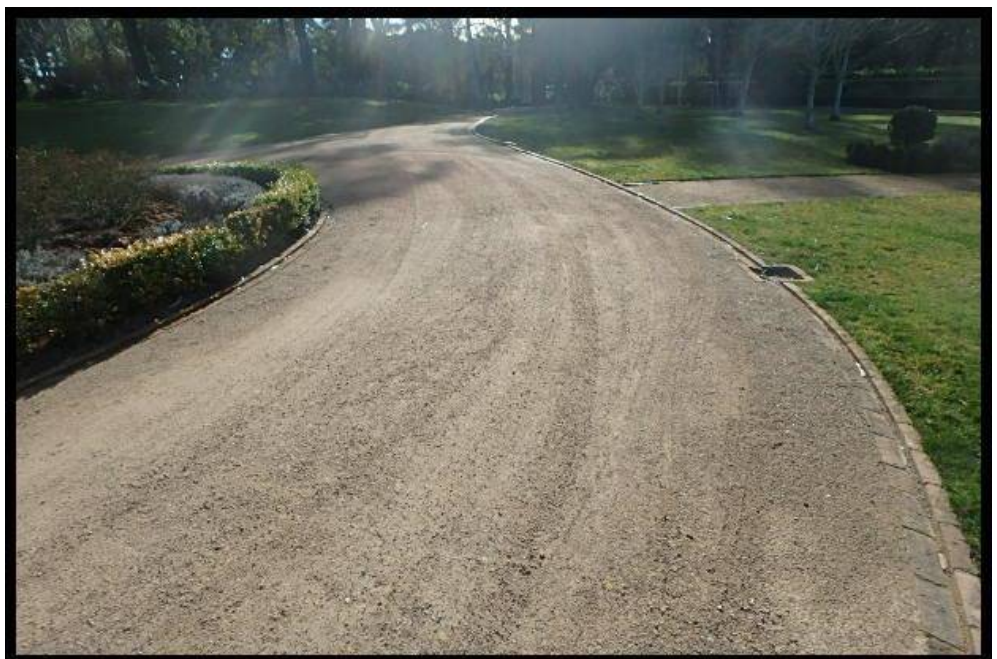
The gravel driveway stands in fair condition.

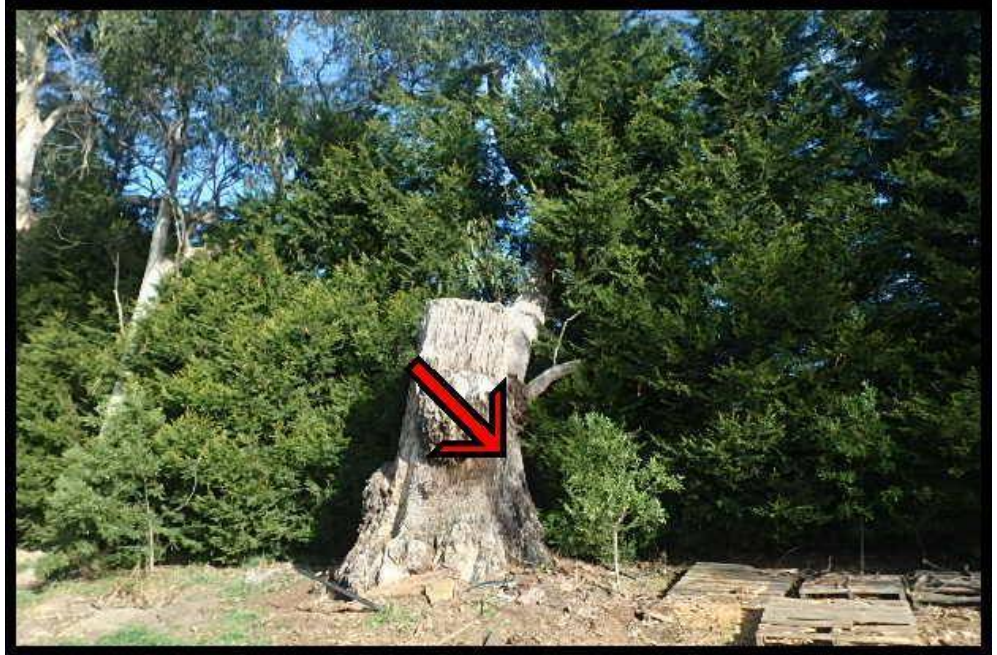
## Affected external timbers

<b>Evidence of termite attack found</b>	<b>Yes - Inspection revealed currently inactive termite attack (damaged timbers and/or termite workings) within this area <u>including but not necessarily limited to</u> the following timbers and the areas listed below.</b>
---	---
