Pest & Building Report

23-56 The Esplanade Bay Village

Sample Unit report

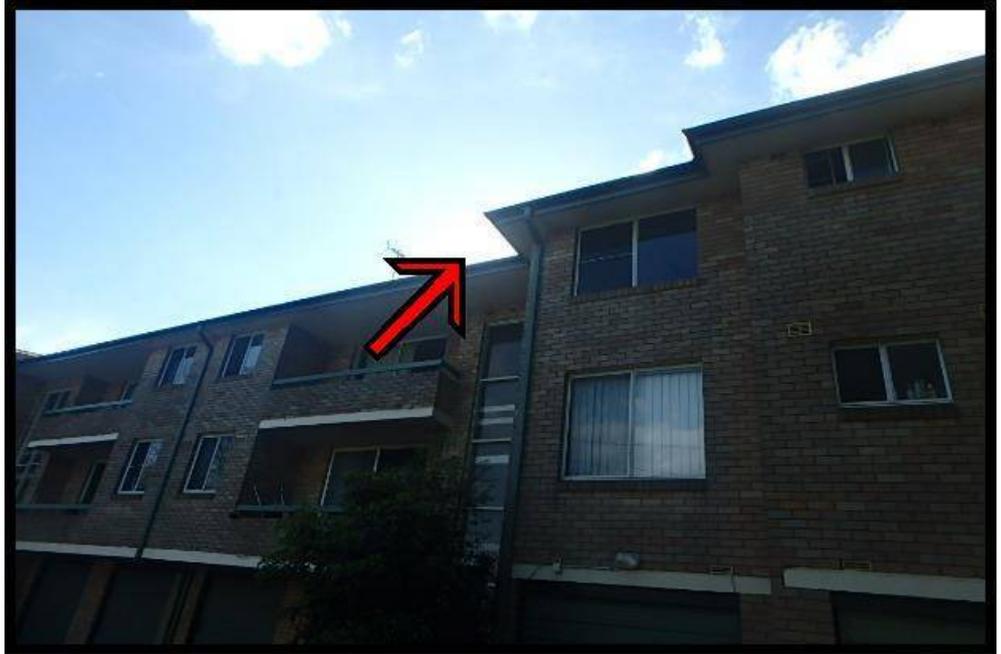
Roof Covering Condition in Detail:

The overall condition of the roof coverings is fair. The surface of the concrete tiles is deteriorating and the area requires sealing.

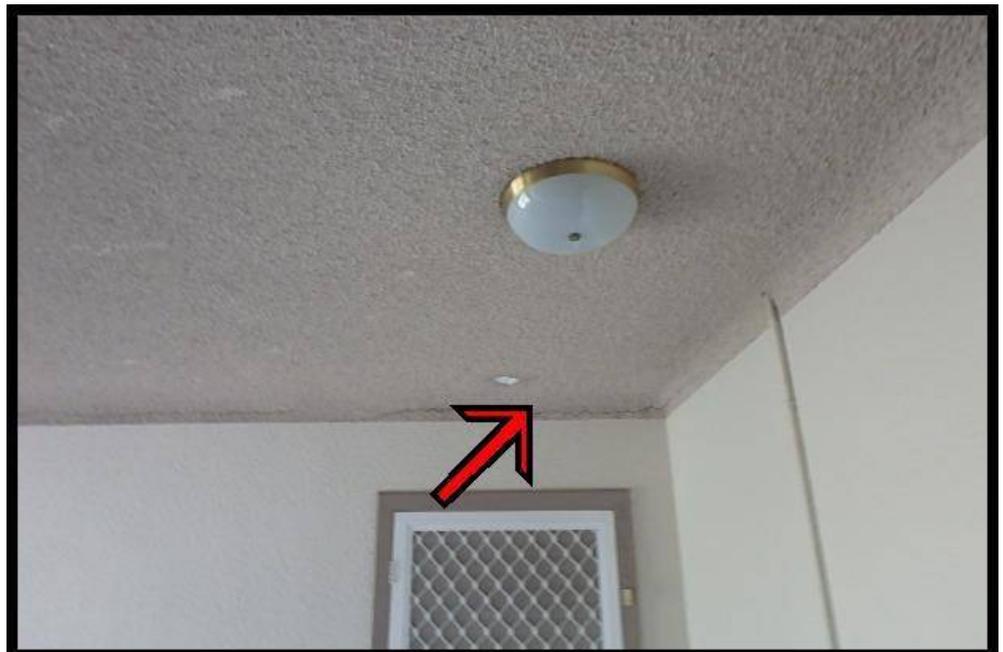
Ceiling Condition:

The condition of the ceilings is generally good. Some minor blemishes were present on the ceiling linings.

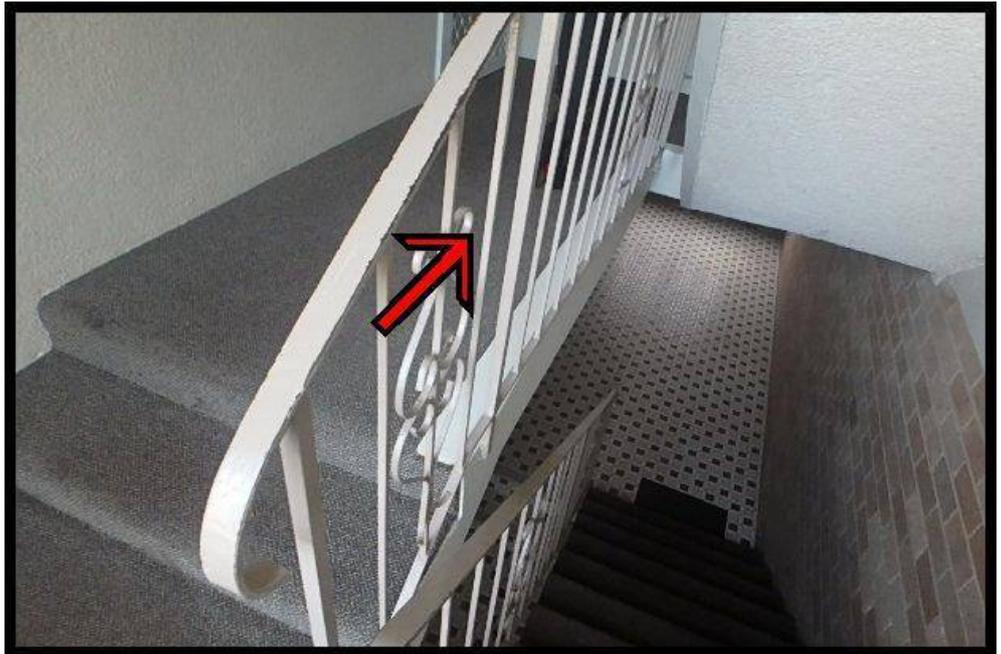
Type & Condition:

The stairs are constructed primarily from concrete. The handrails and balustrades do not appear to comply with the current BCA Standards for height and spacing. Although this report does not generally comment on items of compliance, this issue may become a safety issue and therefore was included in this report. Recommend you further investigate this matter and upgrade if necessary.

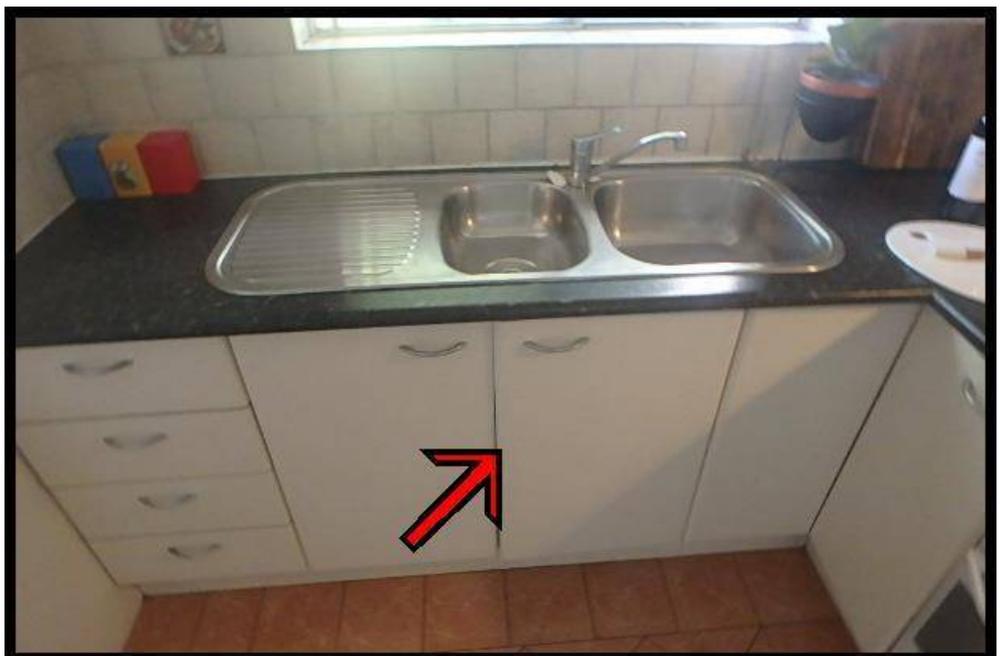
Kitchen Fixtures:

The condition of the fixtures is generally good. Wear and tear is noted to cabinets and/or doors and some maintenance or repairs will be required. Adjustment is required to some door and drawers to ensure smooth operation.

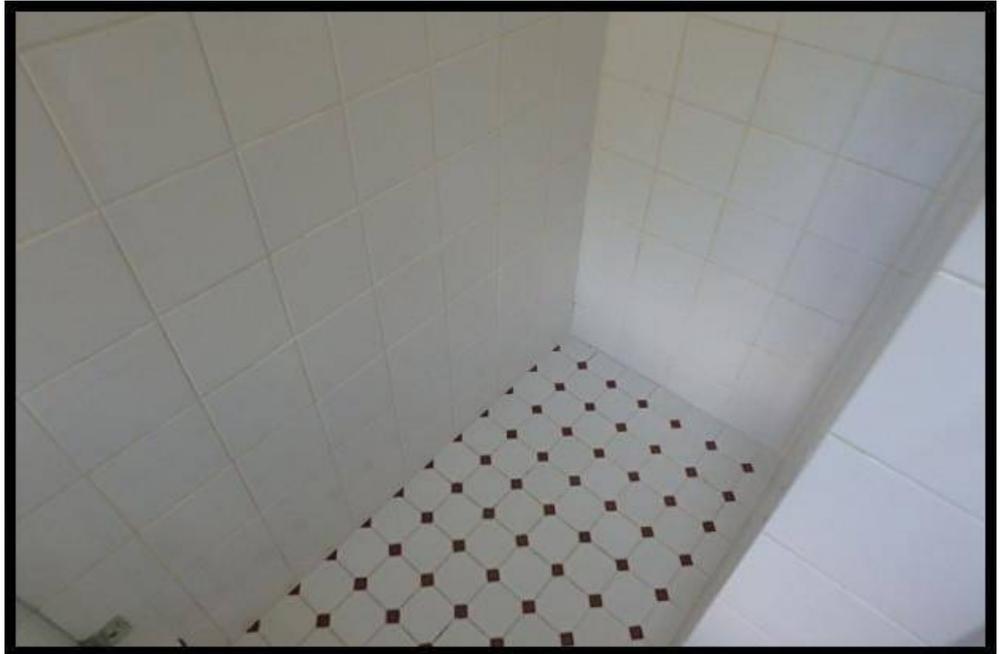
Shower/Bath Condition:

The shower recess was tested and there was no visible water penetration to surrounding areas. The waterproofing on the shower is out of warranty and we recommend the purchaser contact a shower waterproofing company to advise on further waterproofing & extended warranty options. **IMPORTANT NOTE:** This test may not reveal water leaks until the shower is put into constant use and surrounding areas monitored over a period of time.

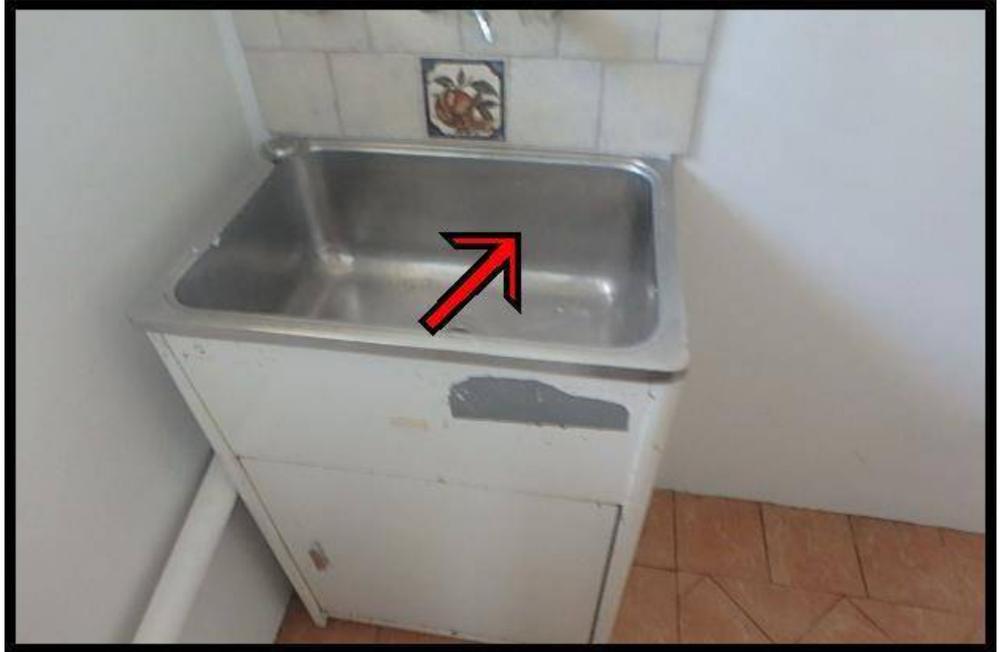
Tub & Taps:

The tub and taps appear serviceable.

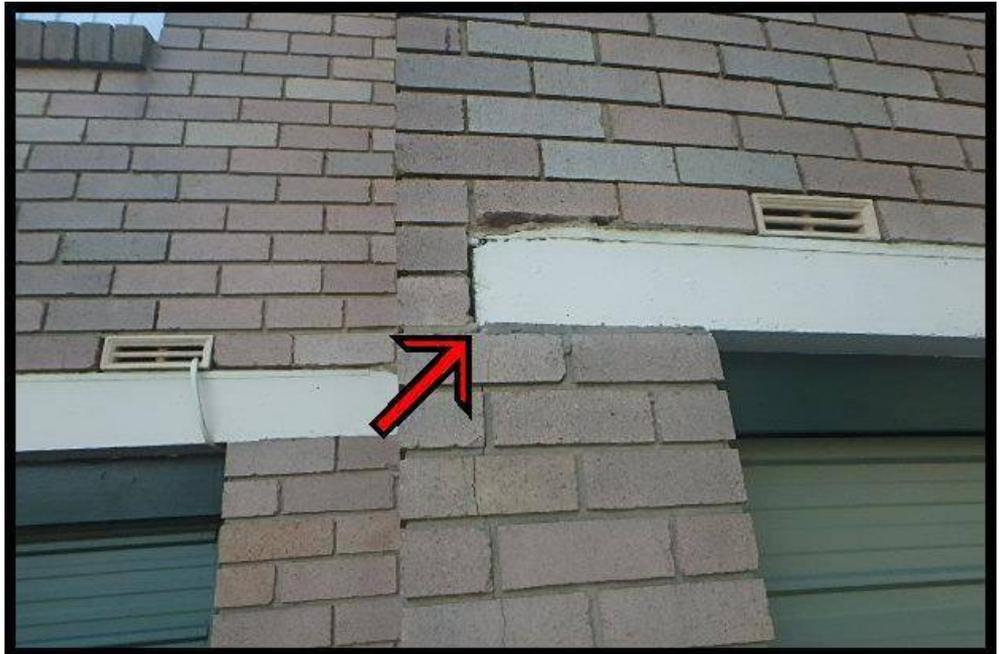
Cracking to Masonry or Concrete Elements:

Cracks are evident. Visible cracking has been categorized as a serviceability defect. Cracking of a building element is a serviceability defect where in the opinion of the inspector the function of the building element is impaired however, the expected consequence of this cracking is unknown until further information is obtained.

Cracking can be expected in a building of this age and construction.

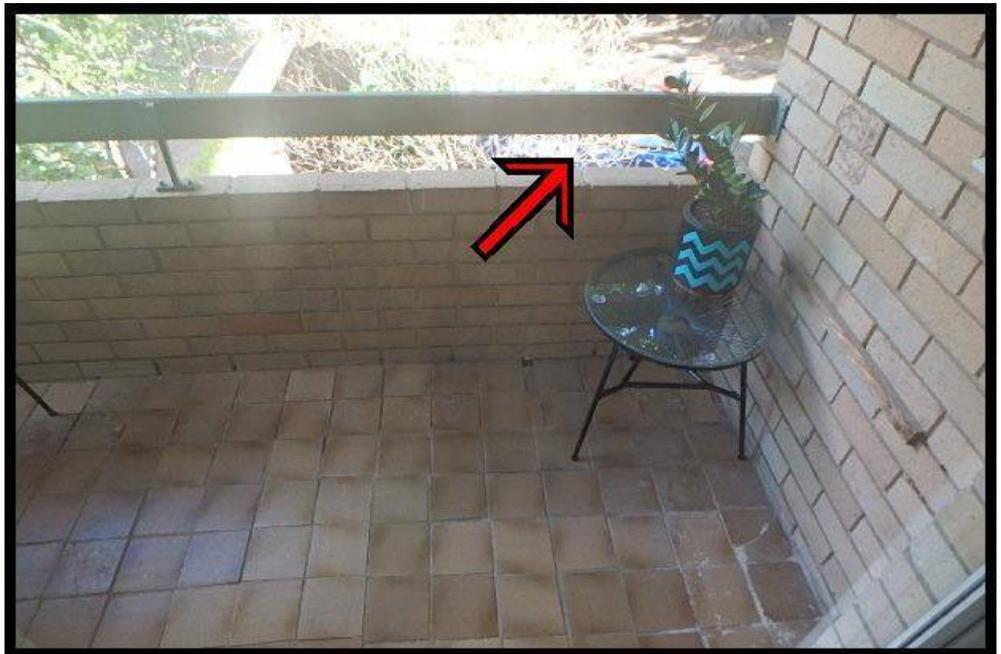
Defects or Maintenance Items:

The height of the handrail does not appear to comply with the current BCA Standards. Although this report does not generally comment on items of compliance, this issue may become a safety issue and therefore was included in this report. Recommend you further investigate this matter and upgrade if necessary.

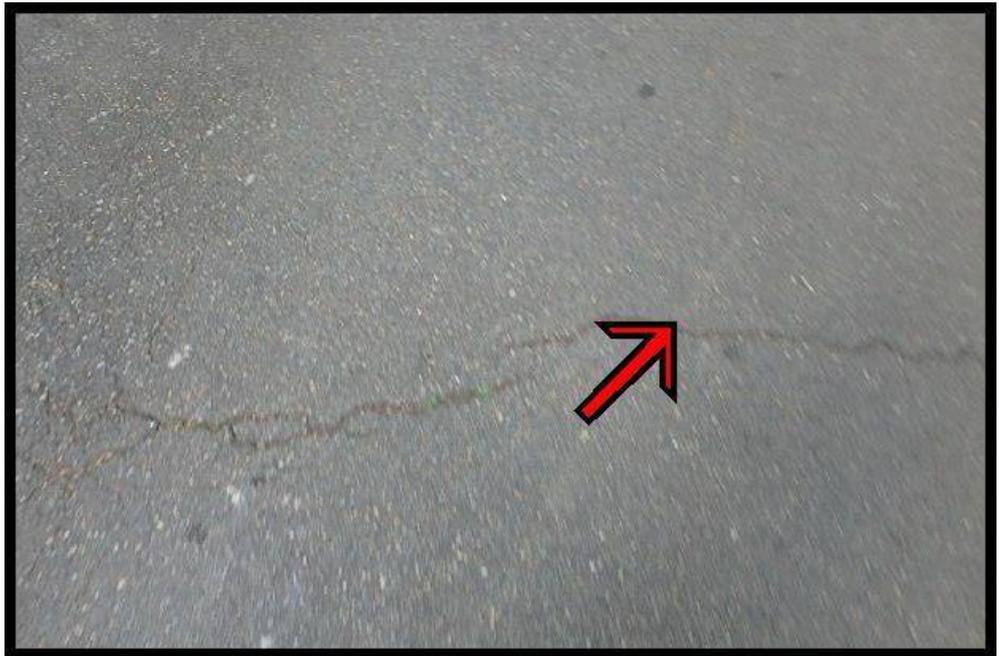
Type & Condition:

The asphalt driveway stands in fair condition. The surface of the driveway is deteriorating and requires repair.

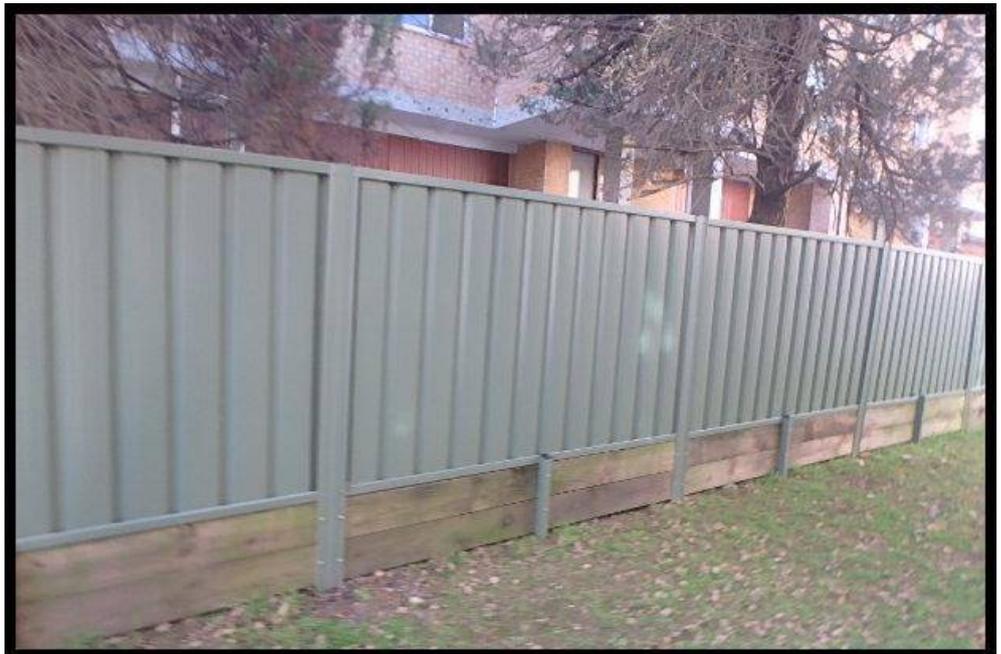
Fences Type & Condition:

The fences are mainly constructed from metal. The fences are generally in fair condition but some repairs or maintenance is required.

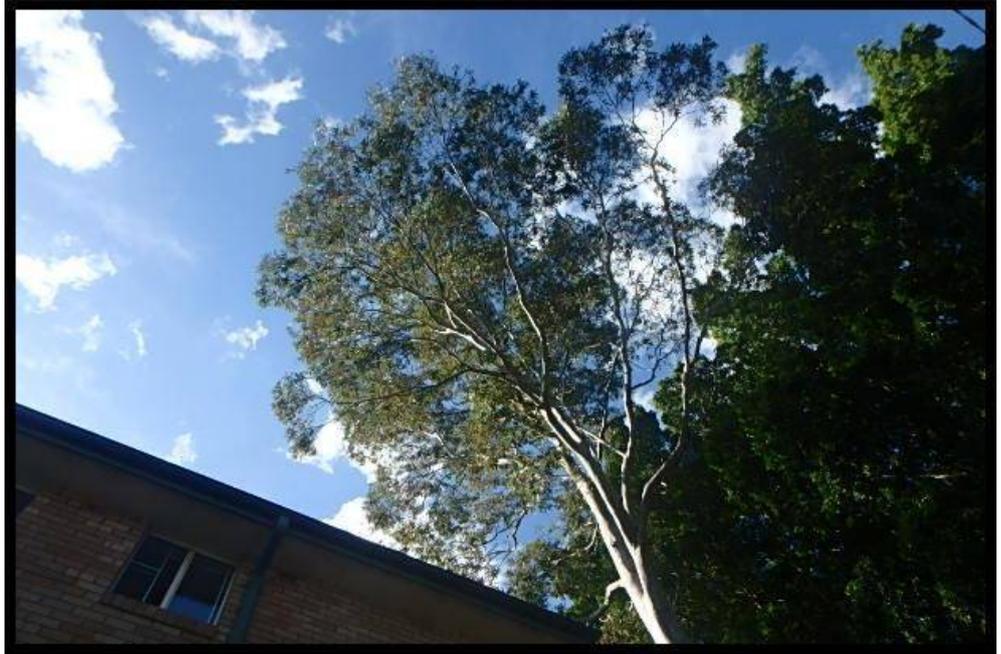
Issue and Location

Trees are located close to the building with tree limbs over the roof area. Consideration should be given to the cutting back of tree limbs over roof areas by a professional contractor.

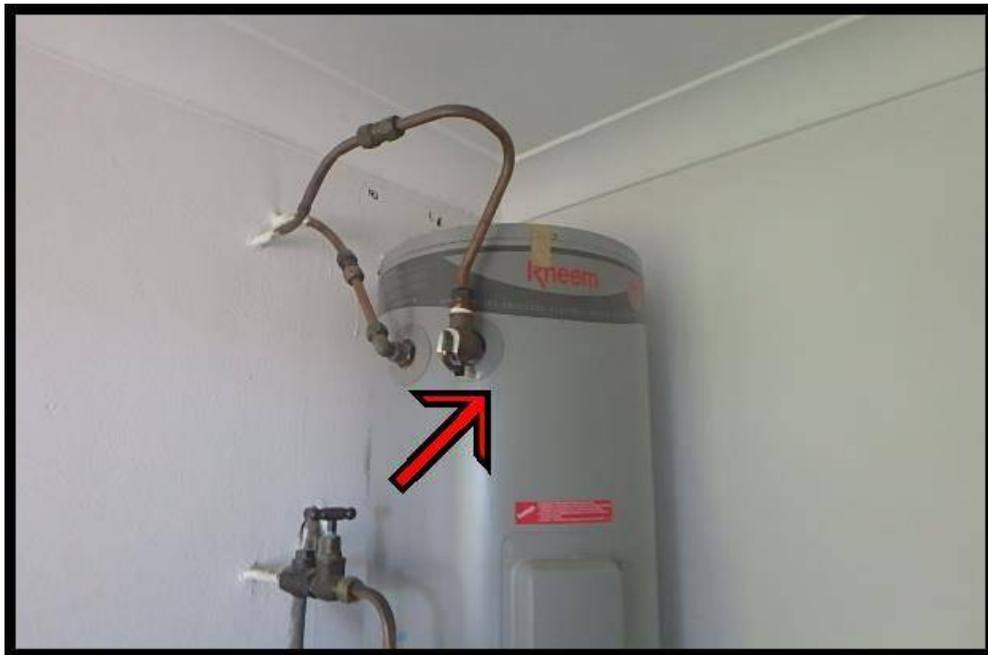
Hot water is provided by the following:

Mains electric hot water system: Mains pressure: Located in the laundry: The hot water system appears to be in working condition. No specific tests other than running the hot water from a tap was carried out. No determination has been made as to the suitability or adequacy of the hot water system in relation to capacity or otherwise.
